Repetitive Loss Area Analysis

City of Arlington, Texas
Public Works and Transportation Department
January 2016

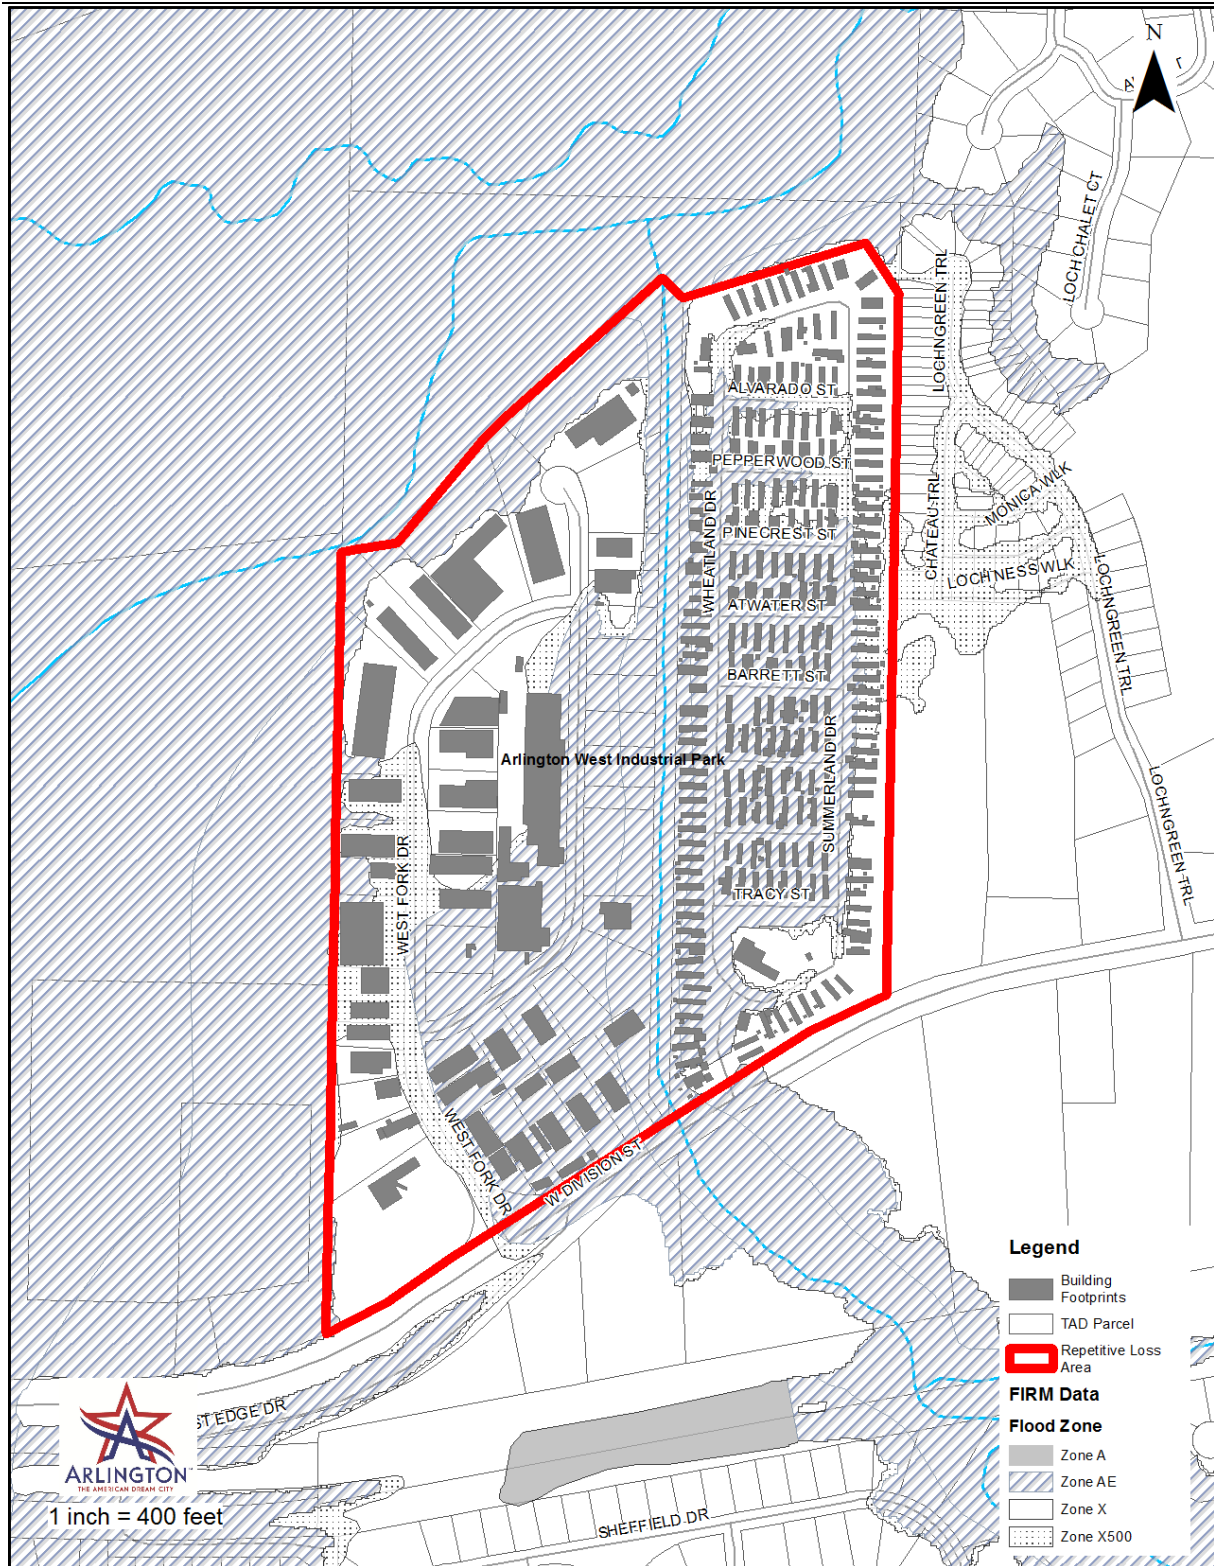
Figure 7 Area #1 Arlington West Industrial Park

In the early 1990s, the US Army Corps of Engineers and the City partnered to line the channel that runs between the industrial park and manufactured home community from Division St. to the outfall into Lower Village Creek for approximately 2,300 feet. About 2/3 of the channel (upstream) was lined with articulated concrete block and the downstream 1/3 was grass lined. Based on the claims information and drainage complaints in the area, it appears that this channel was successful in reducing the frequency of the flooding in the area.

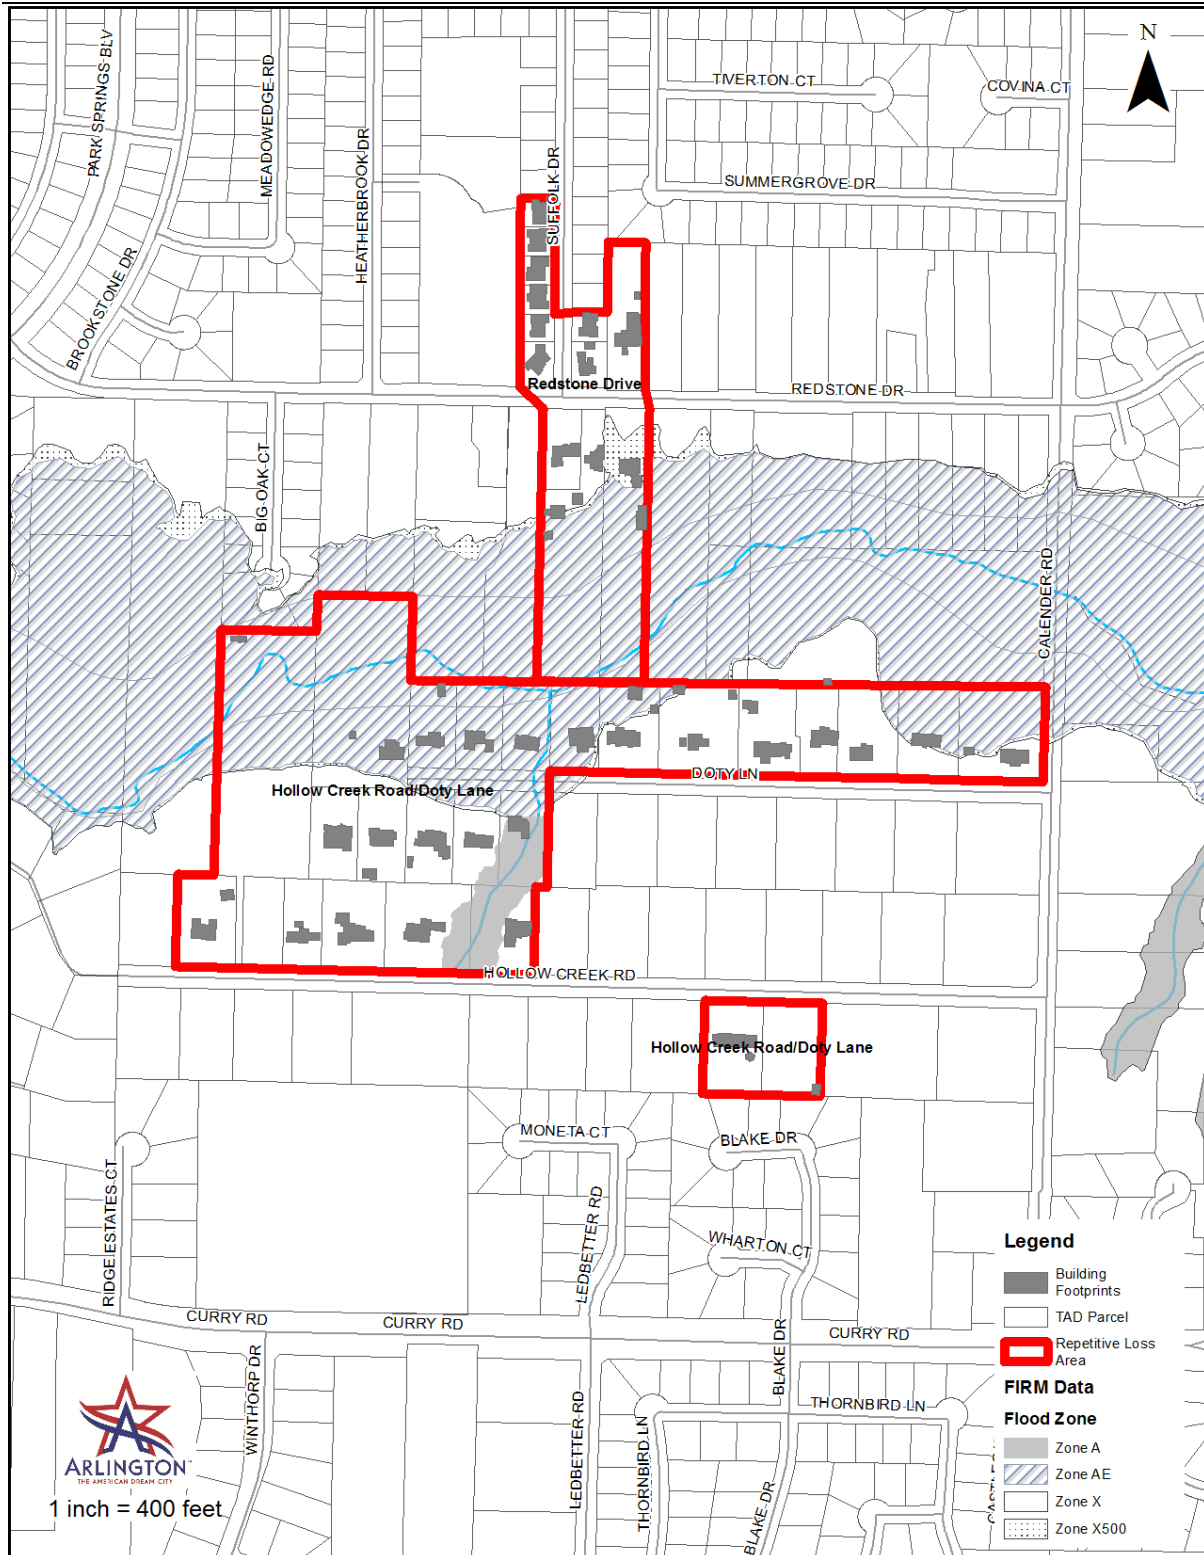
Figure 8 Area #2 Hollow Creek Rd./Doty Lane RLA

A substantial portion of the area (18 of 26 lots) is located within the 100-year (Zone AE) floodplain. Portions of this area are subject to periodic flooding from Sublett Creek. The flooding from Stream RC-1 is generally broad, shallow flooding. This area is very flat with limited drainage facilities in the area. Seventeen homes within the area have reported flooding concerns.

As of November 30, 2015 there are 6 repetitive loss properties located in this area that have made a 18 claims for a total of \$475, 443 since 1977. One property is considered a severe repetitive loss property. The average RL flood claim for each RL property varies from \$2,485 to \$48,099. There have been 12 flood insurance claims at properties that are not repetitive loss properties. A majority of the claims occurred in 1991, 1992, 2004, 2010, and 2015.

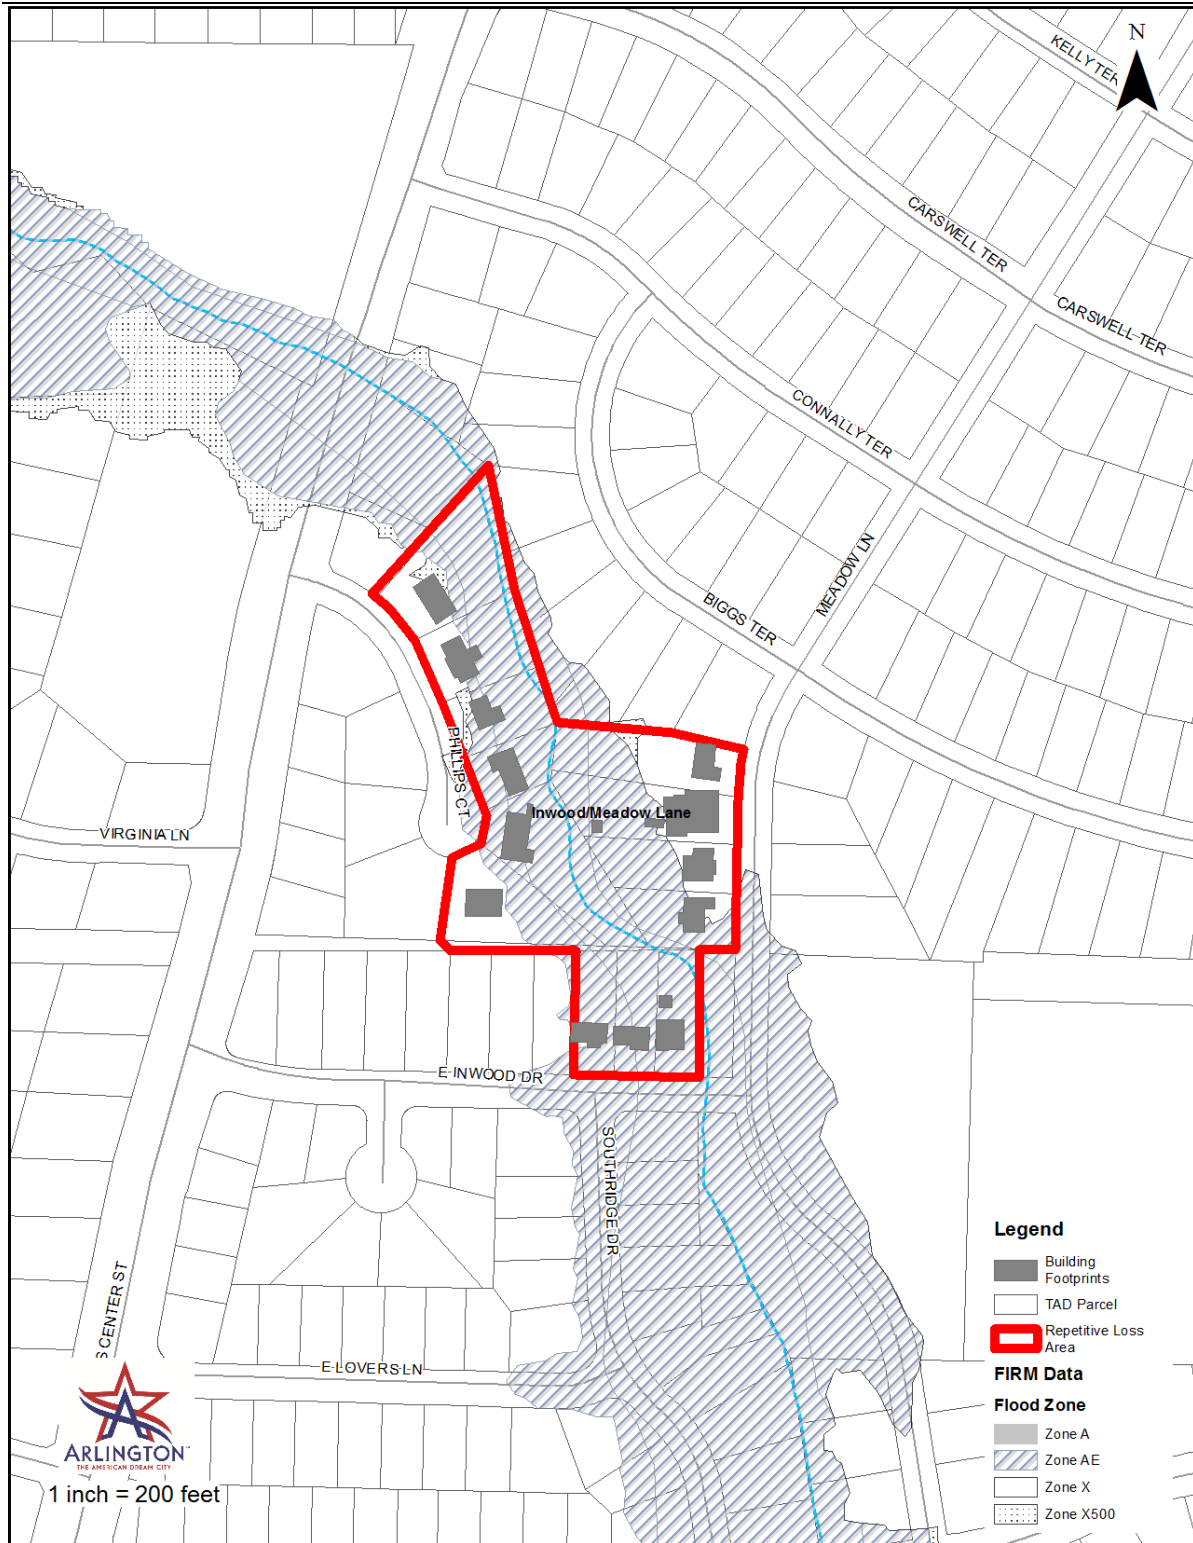
Figure 9 Area #3 Inwood Drive/Meadow Lane RLA

All of the lots are located within the 100-year (Zone AE) floodplain and all are subject to flooding from JC-2. Seven of the 13 lots have reported a drainage concern and there are also erosion concerns in the area.

As of November 30, 2015 there are 2 repetitive loss properties in this area that have made a total of 7 claims for a total of \$61,226 since 1977. A majority of the claims were in 1981, 1995, 2001, and 2015.

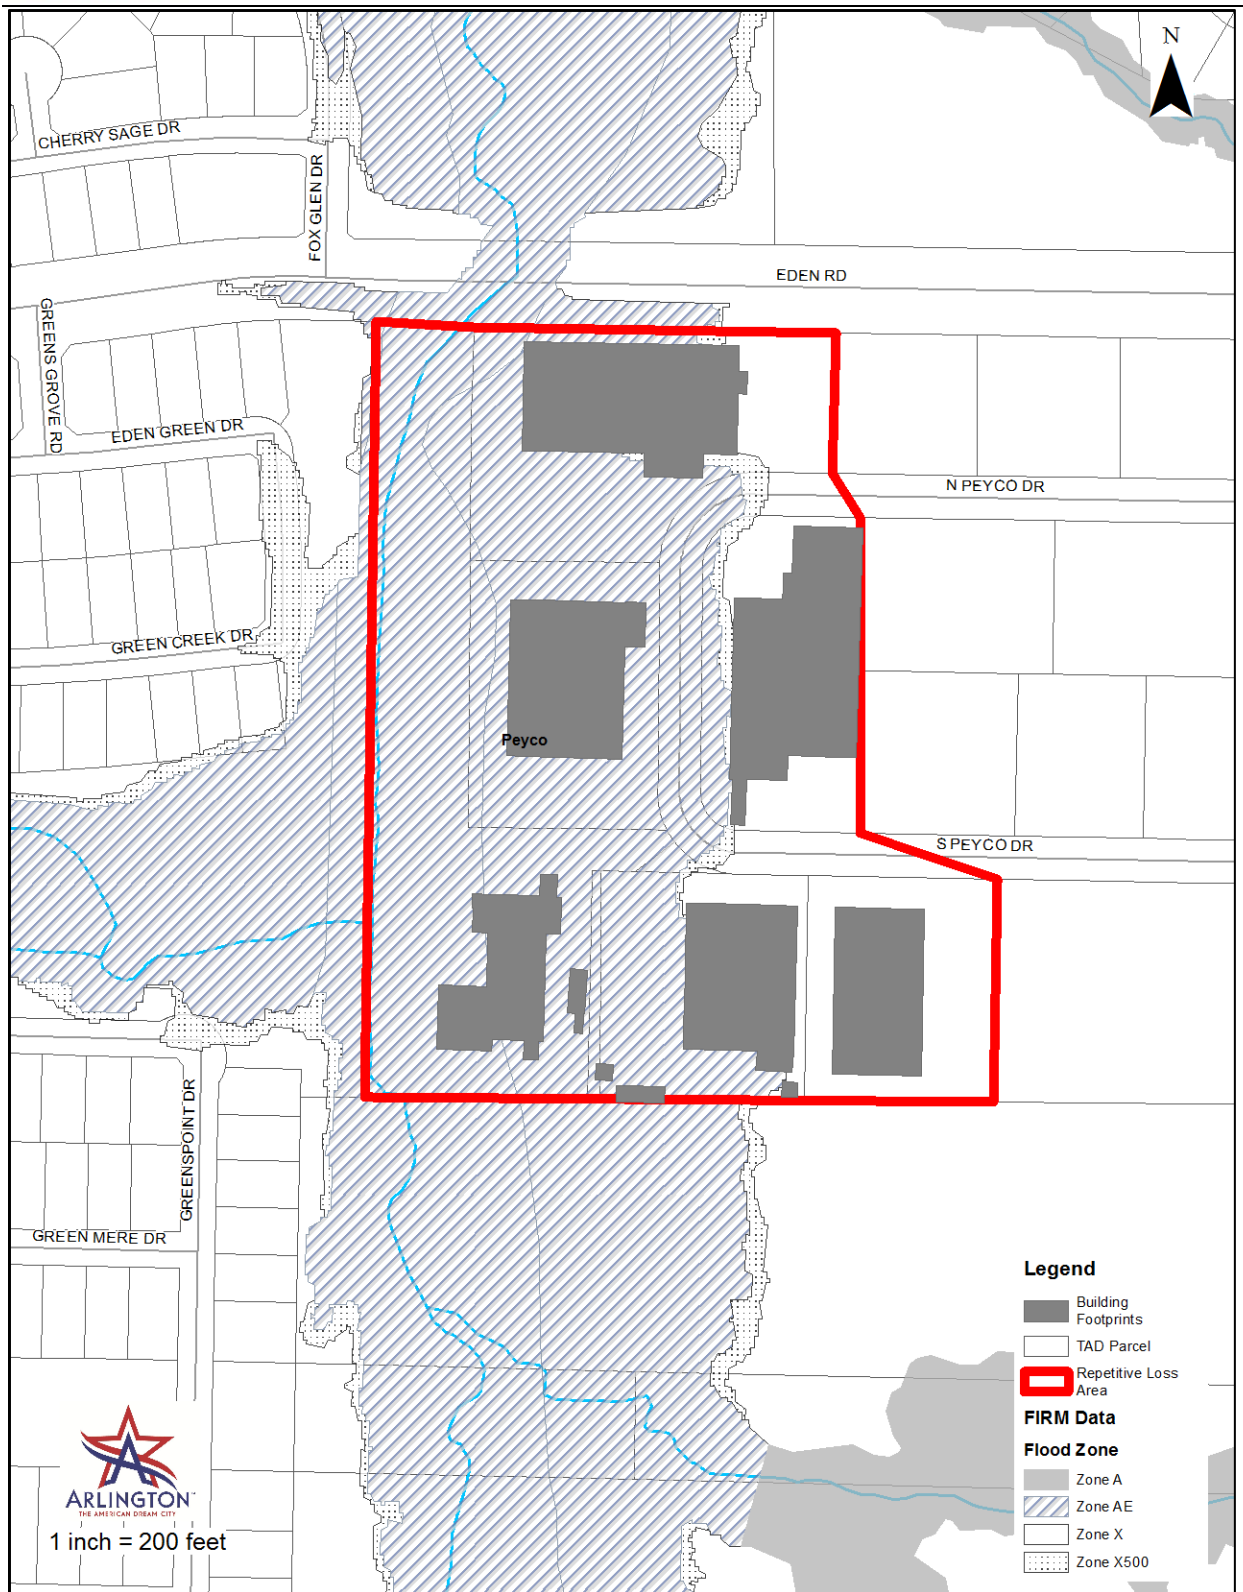
Figure 10 Area #4 Peyco Industrial Park RLA

Six light industrial warehouses are subject to structural flooding for events up to the 1% annual probability event. Of these, two are subject to flooding during the 4% annual probability event, and one is subject to flooding during the 10% annual probability event. The industrial park encroaches into the floodway of Upper Rush Creek, with paved areas extending to and encroaching the natural banks of the channel. The buildings have a history of significant repetitive flood losses, and there was a flood related fatality in 2004.

As of November 30, 2015 there are 2 repetitive loss properties in this area that have made 6 claims for a total of \$762,035 since 1977. The average flood claim ranges between these two properties from \$41,927 to \$297,163. A majority of the claims occurred in 2004, 2006, and 2010.

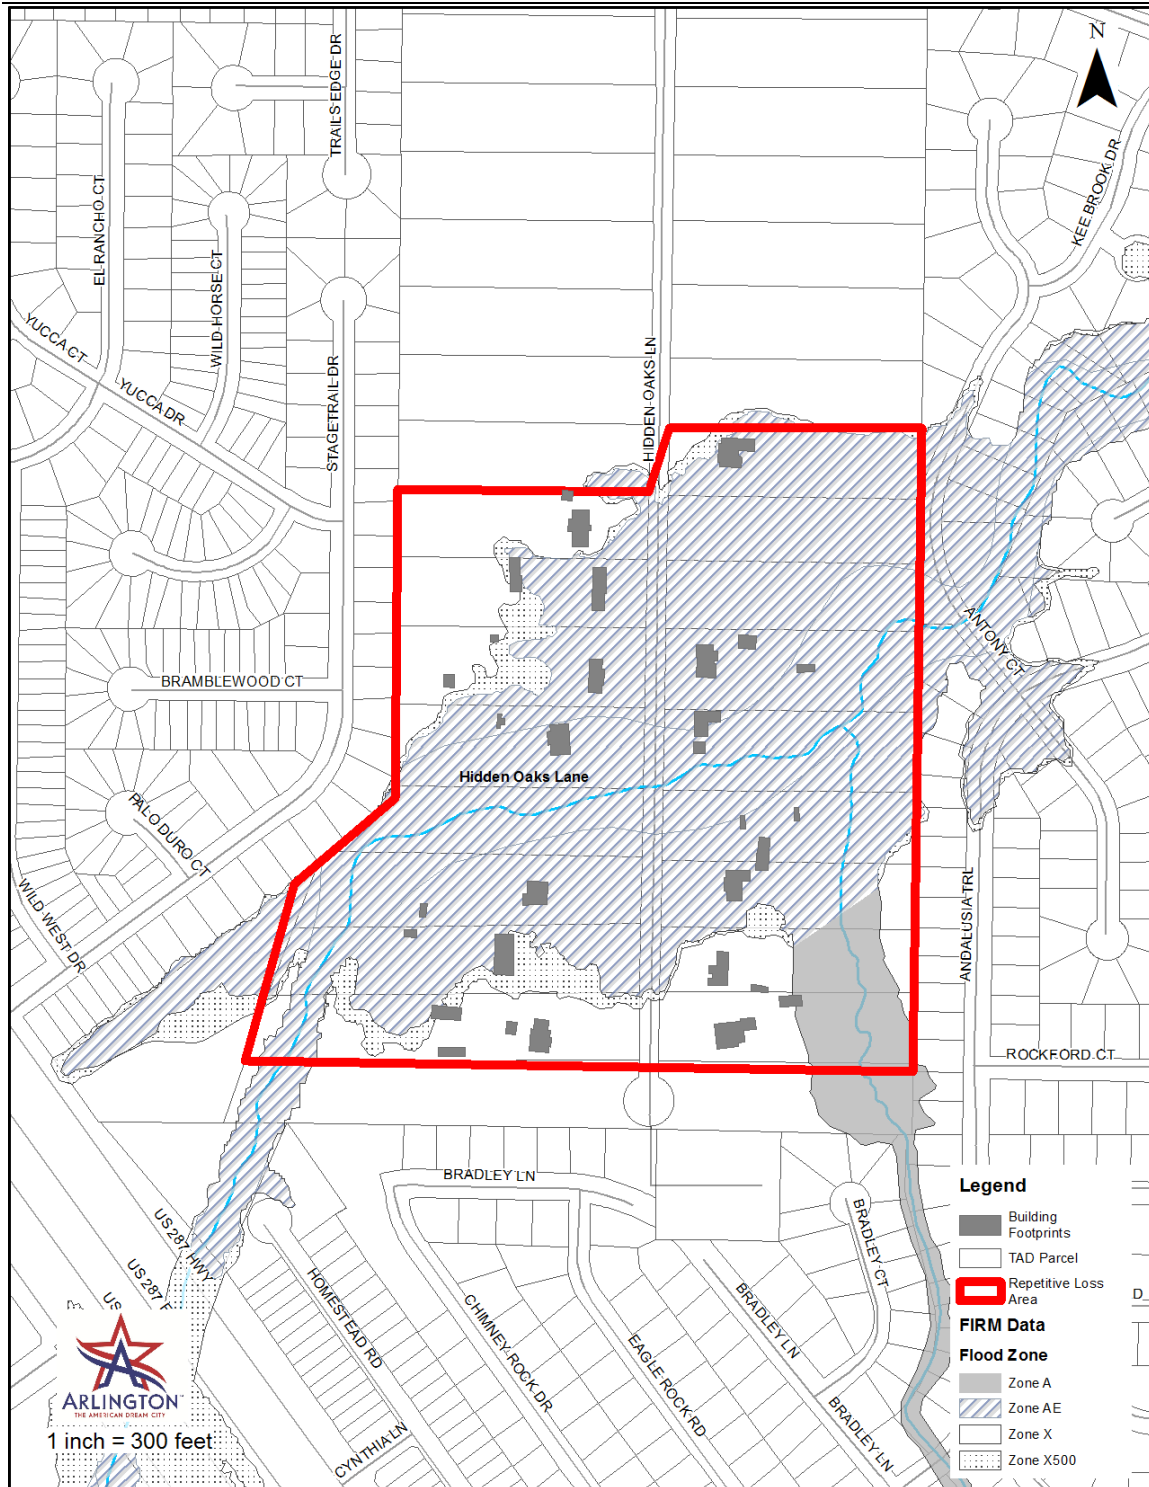
Figure 11 Area #5 Hidden Oaks Lane RLA

While there have been flood insurance claims in this area, the drainage concerns in this area have been mostly related to creek maintenance and erosion. This area is flat and the floodplain associated with Kee Branch leads to broad, shallow flooding.

As of November 30, 2015 there is one severe repetitive loss property located in this area that has made 5 claims for a total of \$231,351 since 1977. The average RL flood claim is \$46,723. A majority of the claims occurred between 1090 and 1991 with the most recent in 2010. Additionally there have been 5 flood insurance claims in this repetitive loss area at other properties. Most claims occurred in the early 1990s, while the most recent were in 2010.

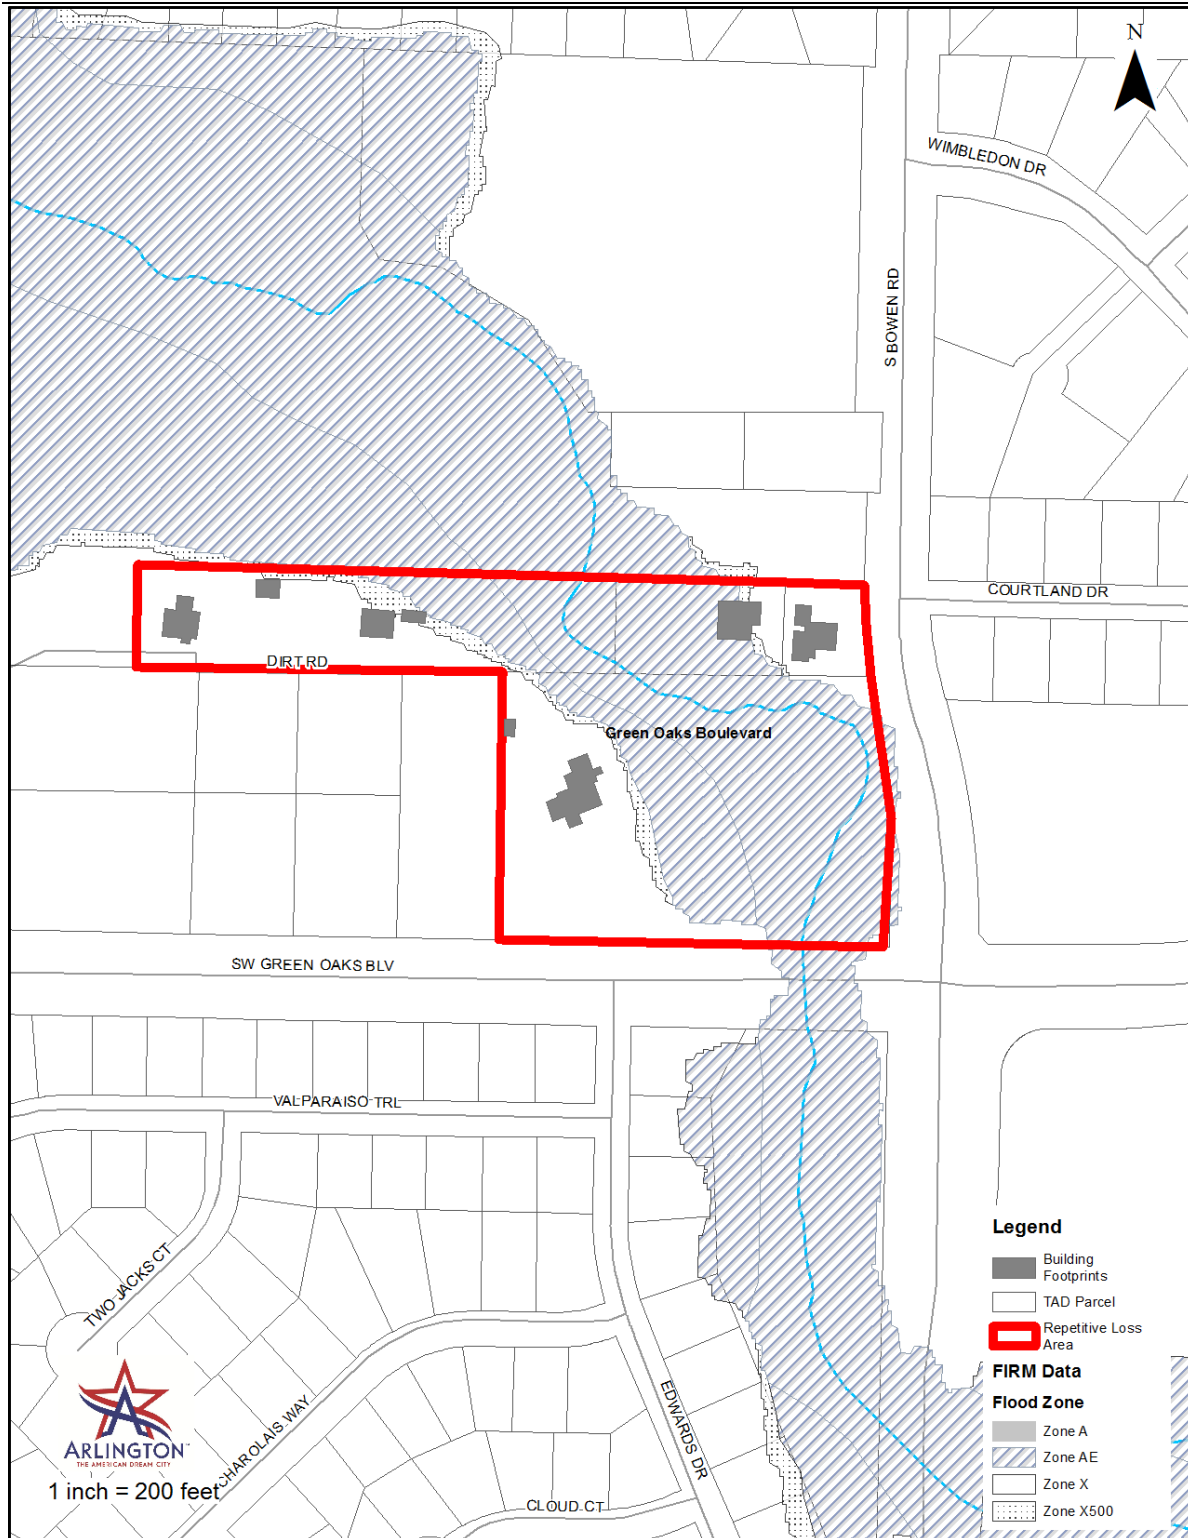
Figure 12 Area #6 Green Oaks Blvd RLA

As of November 30, 2015 there is one repetitive loss property in this area that has made 4 claims for a total of \$141,053 since 1977. The average flood claim is \$35,263. A majority of the flood claims occurred in 2004, 2006, and 2010.

The repetitive loss claims for this area are related to an accessory structure. The structure has been removed. Three properties in this area have reported drainage concerns. All of the concerns are related to erosion along the creek.

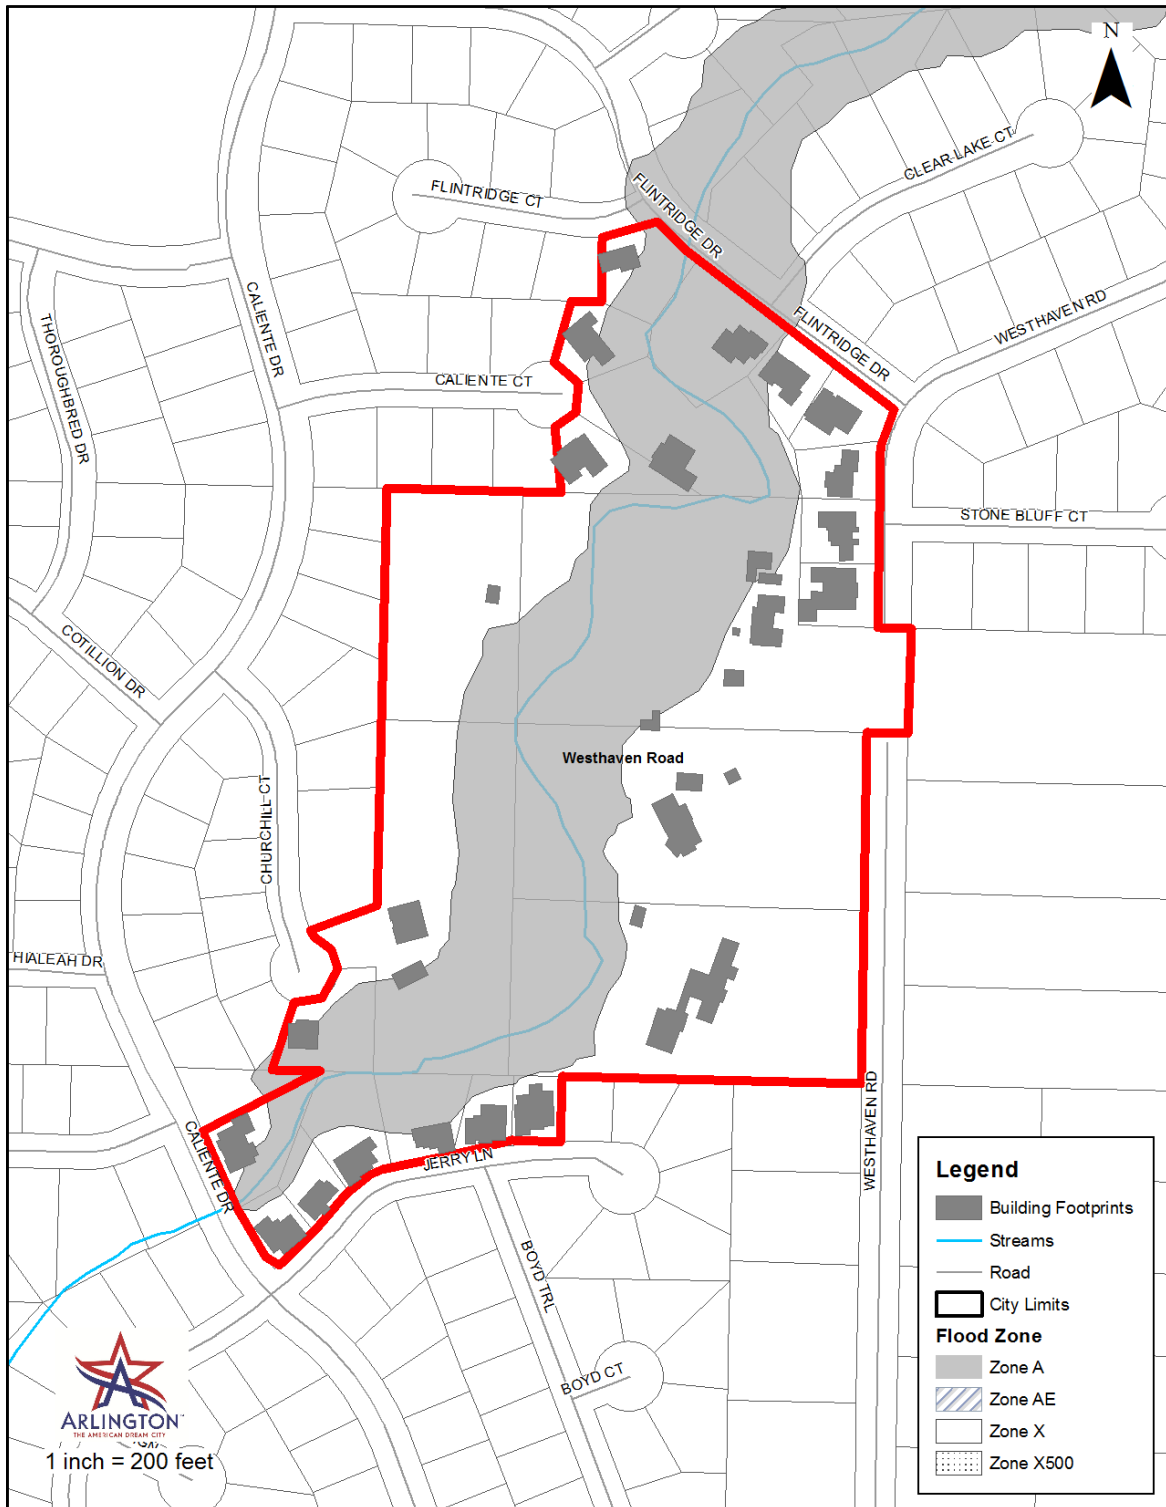
Figure 13 Area #7 Westhaven Road RLA

Eight properties have reported drainage concerns in this area. Most of them have been either erosion or creek maintenance related. One of the repetitive loss properties floods due to lot to lot drainage. The other floods related to the convergence of the tributary with the main stem of Rush Creek.

As of November 30, 2015 there are 2 repetitive loss properties in this area that have made 5 claims for a total of \$286,919 since 1977. The average flood claim ranges from \$19,628 to \$82, 554. A majority of the flood claims occurred in 2004 and 2007.

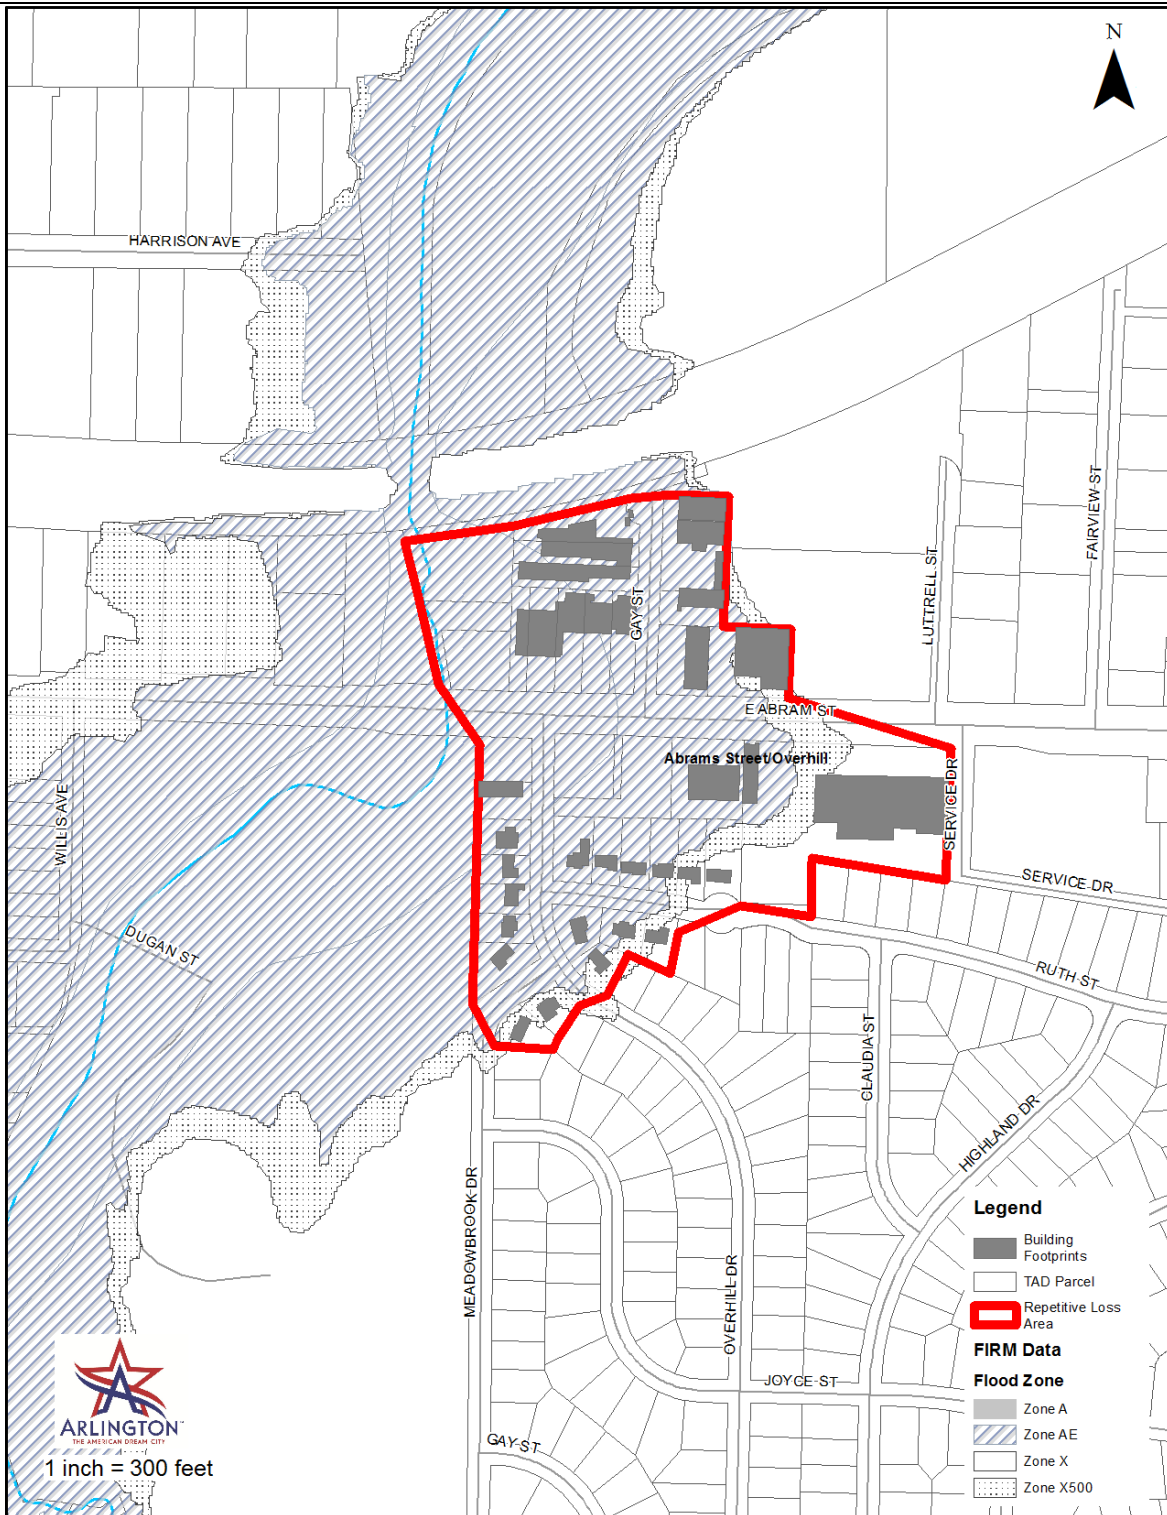
Figure 14 Area #8 Abram St/Overhill RLA

Five properties have reported drainage concerns in this area. The concerns vary from street related to lot to lot drainage issues. Most are private property issues that have been addressed through coordination with adjacent property owners. One is related to flows coming from Abram Street. This will be addressed through the Abram Street rebuild which is currently occurring.

As of November 30, 2015 there are 4 repetitive loss properties in this area that have made 8 claims for a total of \$130,805. Two repetitive loss properties have been purchased and demolished by the City of Arlington and are considered to be mitigated. The average flood claim for the repetitive loss property ranges from \$3,297 to \$25,681. A majority of the flood claims occurred in 1995.

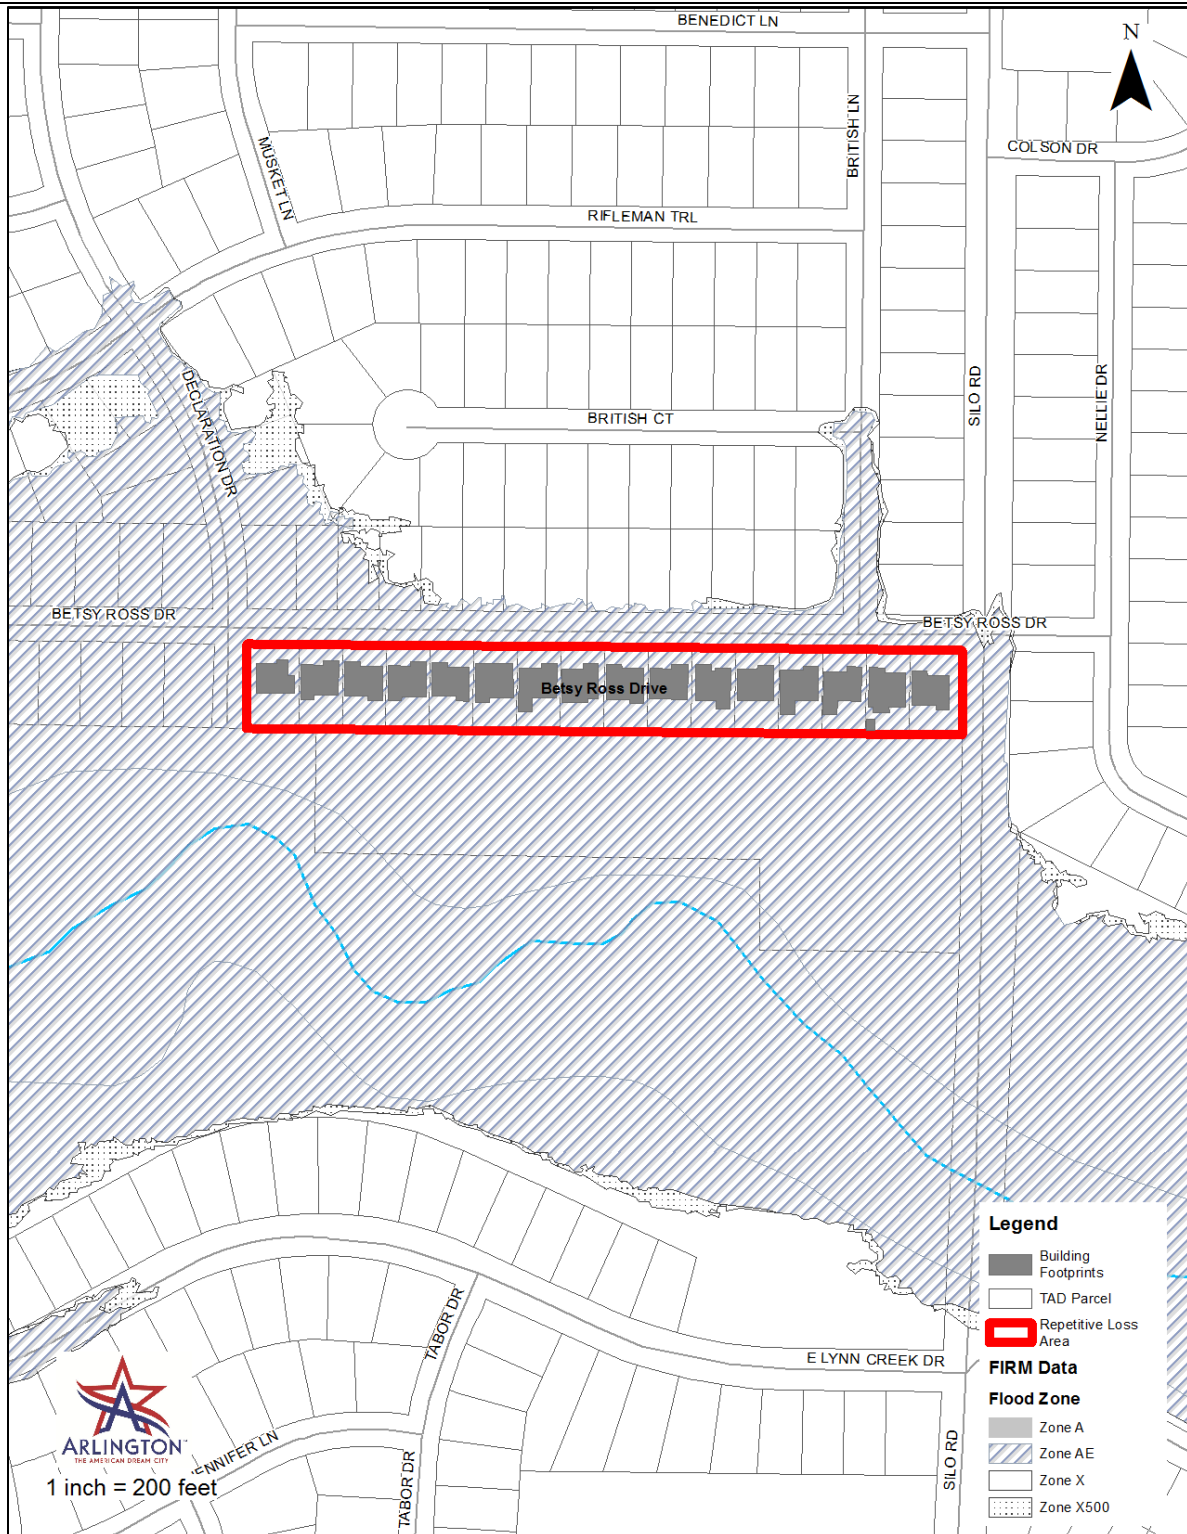
Figure 15 Area #9 Betsy Ross Drive RLA

There are three properties that have reported drainage concerns in this area. Two of the three reported structural flooding and all mentioned the maintenance condition of the creek as a concern.

As of November 30, 2015 there is one repetitive loss property in this area that has made 3 claims for a total of \$11,564 since 1977. The average flood claim is \$5,782.

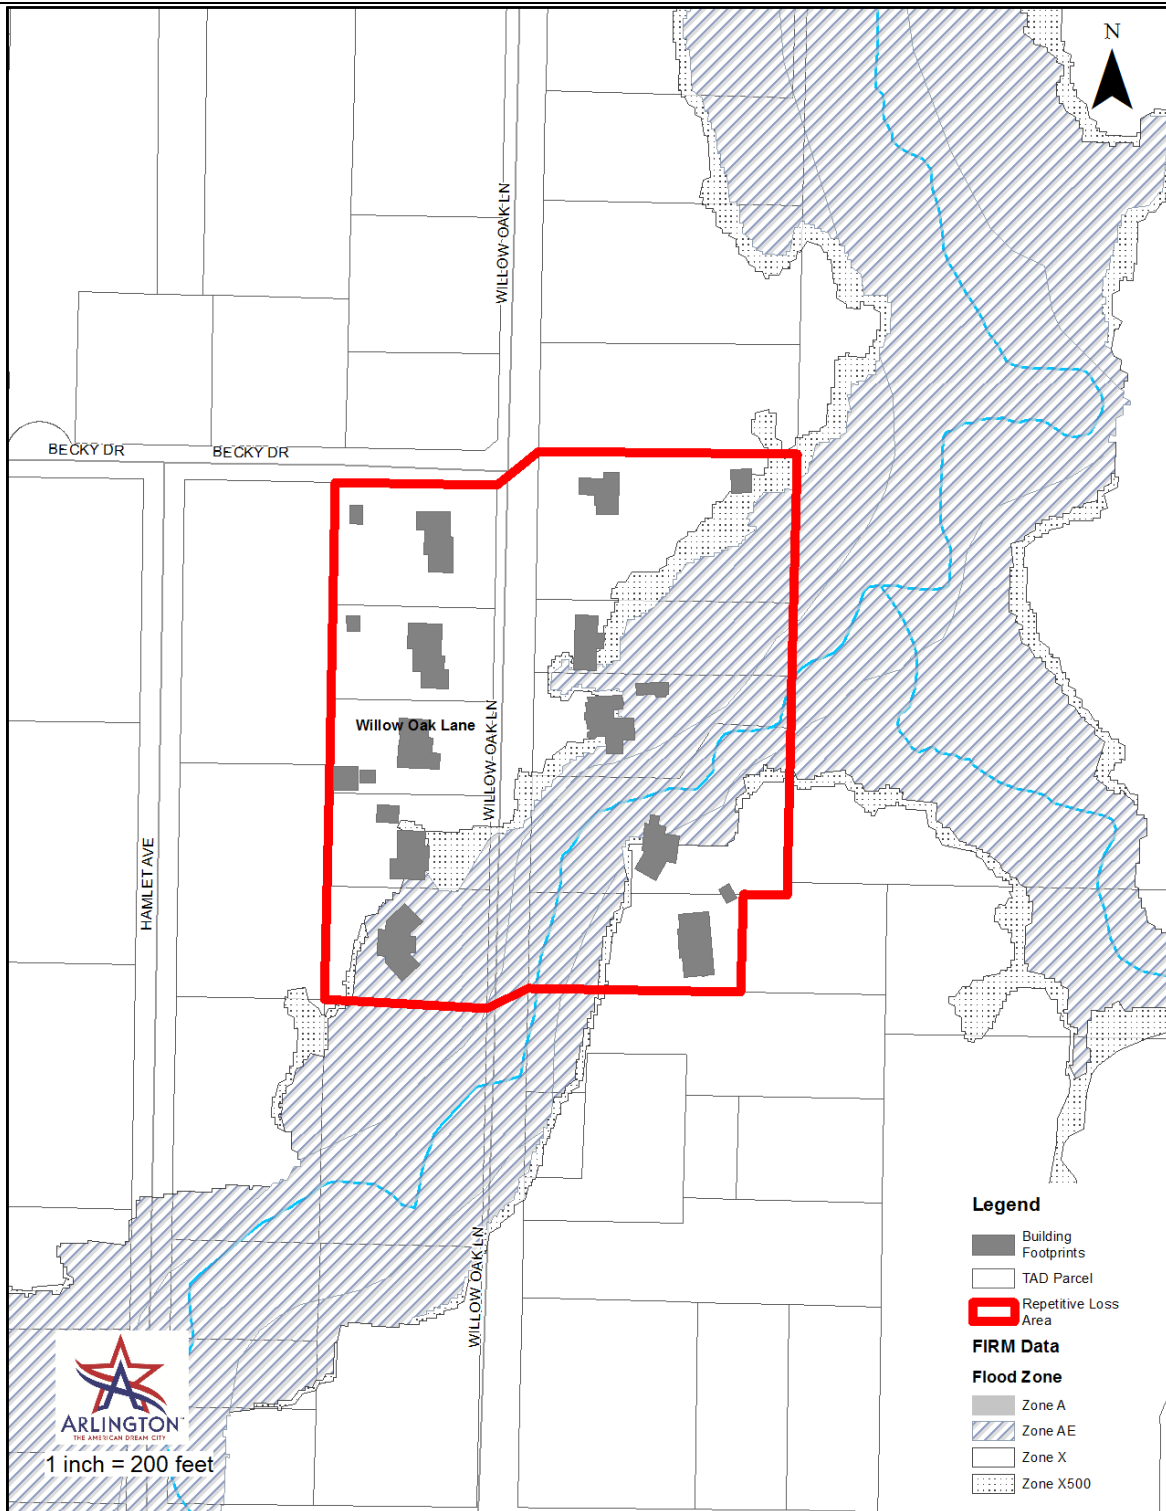
Figure 16 Area #10 Willow Oak Lane RLA

Seven properties have reported drainage concerns in this area. The problems reported are either related to ditch grading and driveway culverts or the floodway crossing the roadway and causing flooding and access issues.

As of November 30, 2015, there is one repetitive loss property in this area that has made 2 claims for a total of \$8,854 since 1977. The claims occurred in 2006 and 2015.

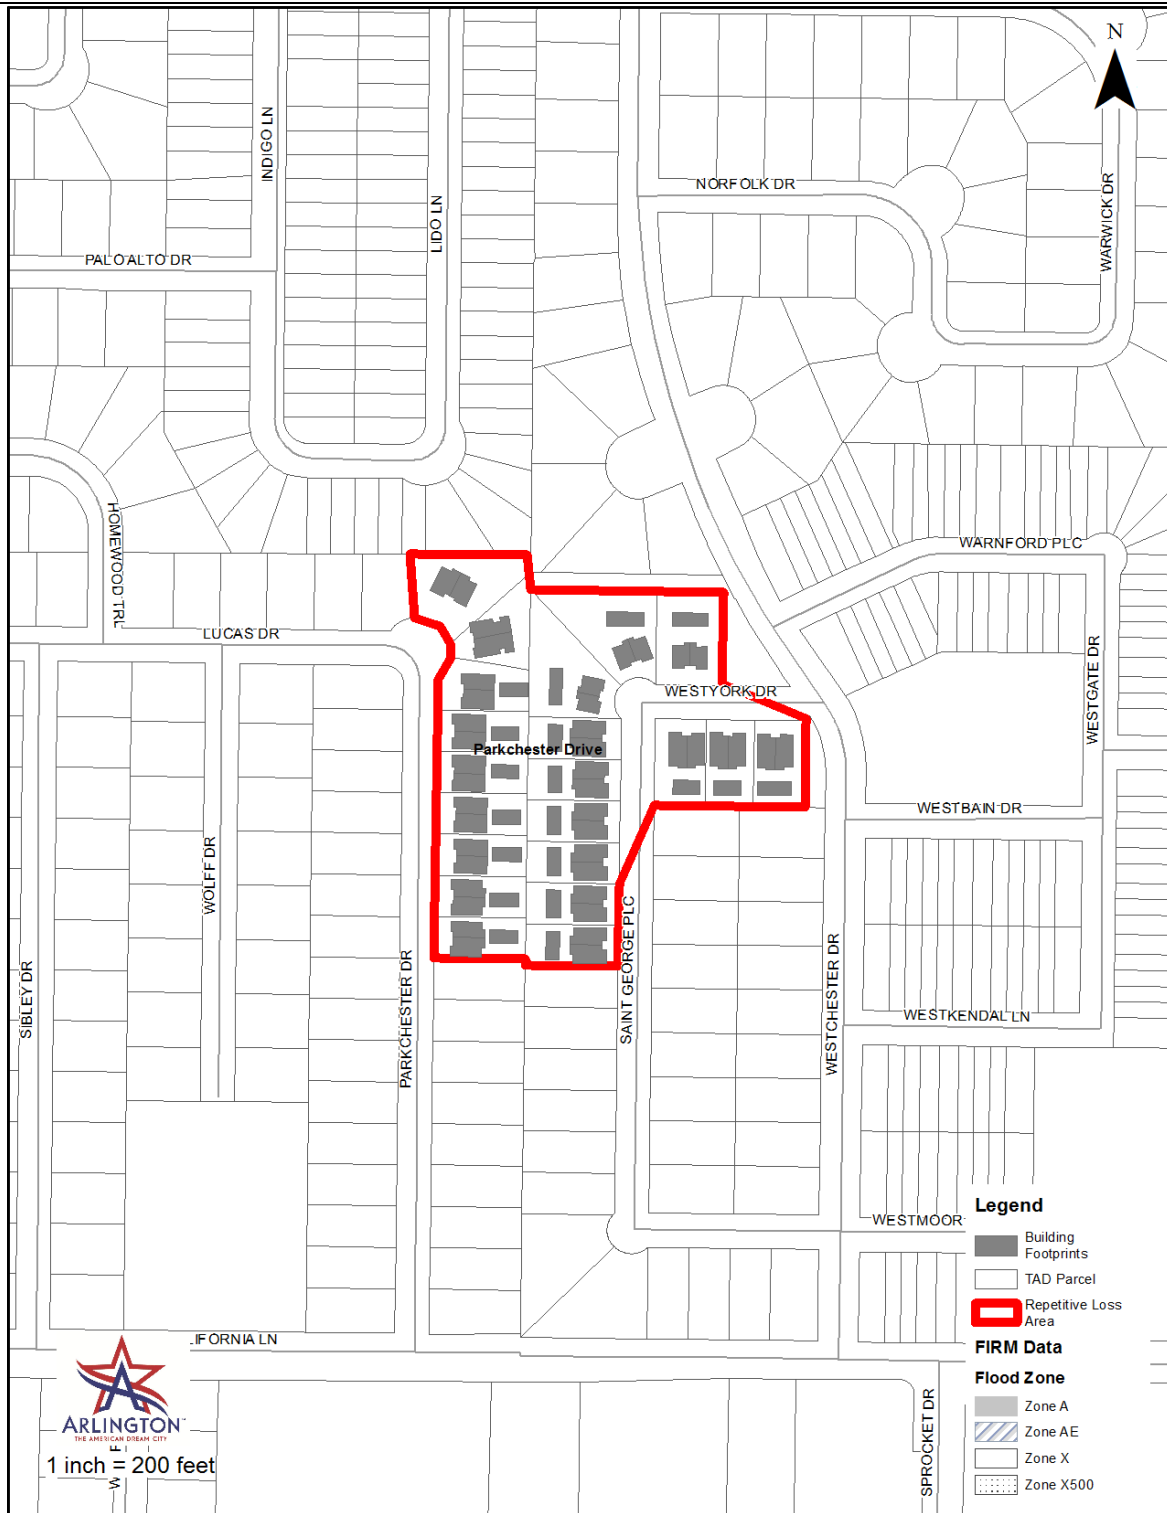
Figure 17 Area #11 Parkchester Drive RLA

Four properties have reported drainage concerns in this area. The area is extremely flat, there is limited storm drain, and the channel is undersized.

As of November 30, 2015 there is one repetitive loss property in this area that has made 2 claims for a total of \$4,535 since 1977. The average flood claim is \$2,268. The flood claims occurred in 1989 and 1991.
