Repetitive Loss Area Analysis

City of Arlington, Texas
Public Works and Transportation Department
January 2016

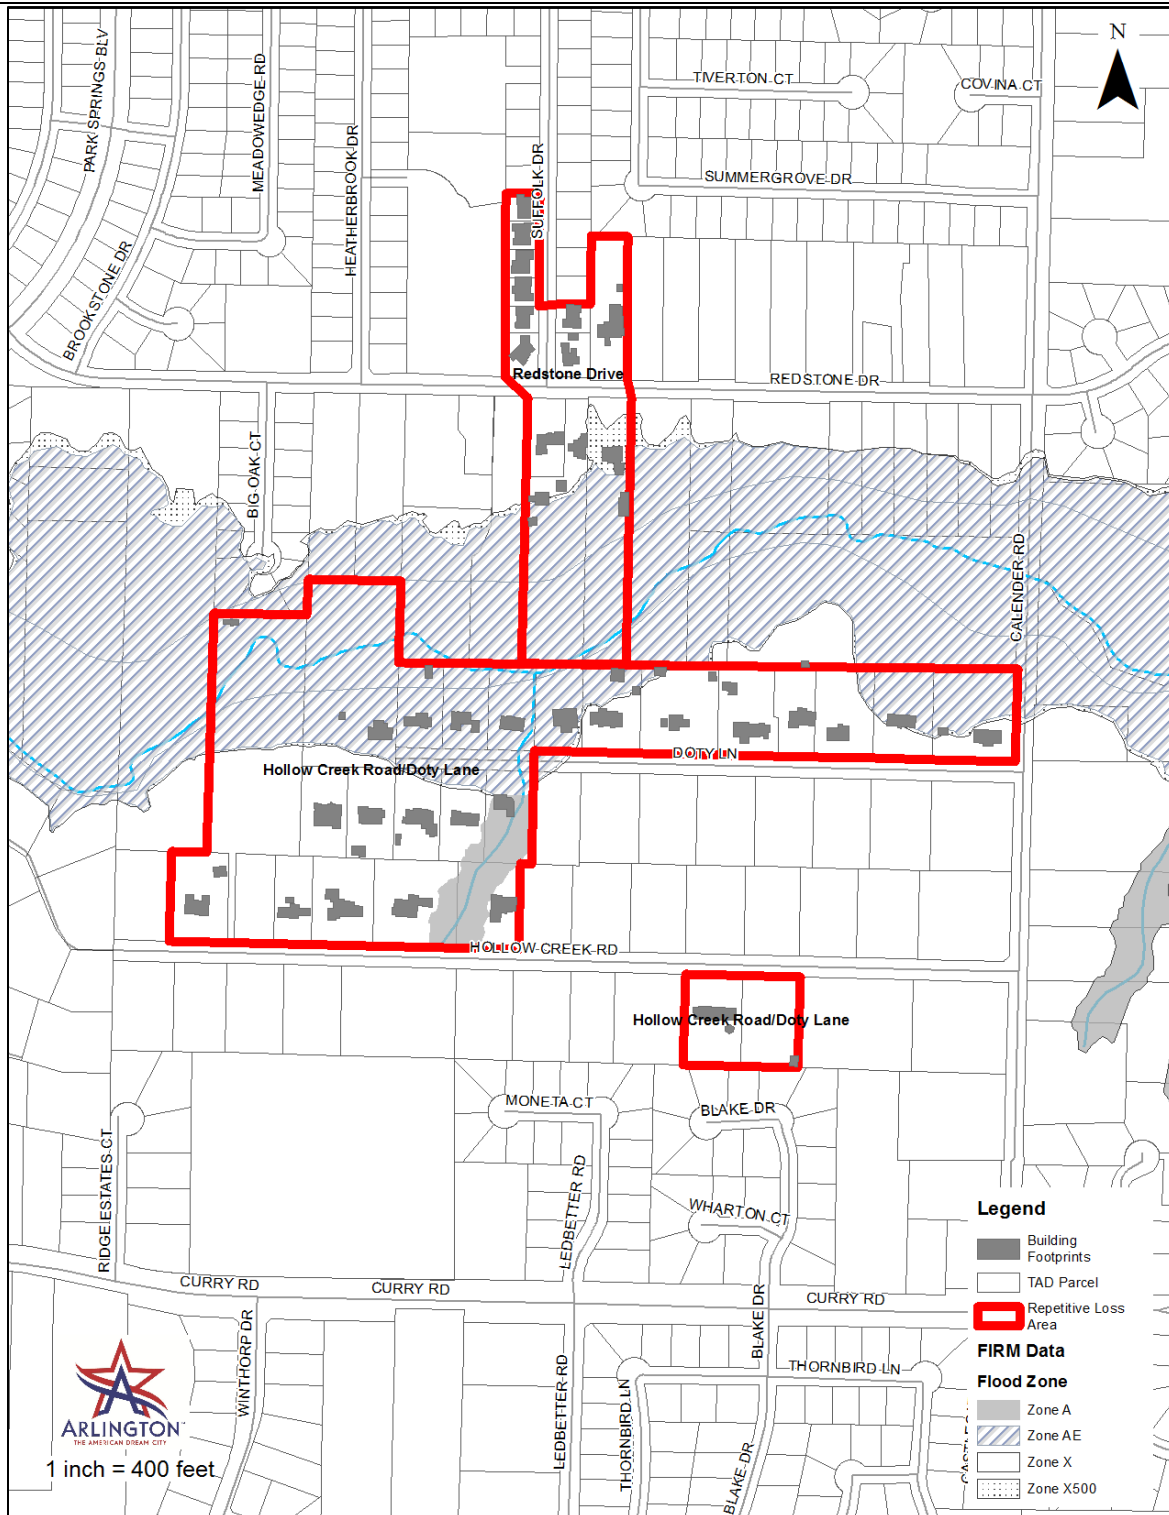
Figure 13 Area #12 Redstone Drive RLA

Eight properties have reported drainage concerns in this area. Complaints to the west of Suffolk Drive are related to drainage from the west as well as lot to lot issues from north to south flow. Complaints on the east side of Suffolk Drive are related to the condition of a storm drain pipe that runs to the rear of the lots. Complaints to the south side of Redstone are related to the condition of an existing earthen channel.

As of November 30, 2015 there is one repetitive loss property in this area that has made 2 claims for a total of \$24,303 since 1977. The average flood claim is \$12,151. The flood insurance claims occurred in 2004 and 2006.
