Repetitive Loss Area Analysis

City of Arlington, Texas
Public Works and Transportation Department
January 2016

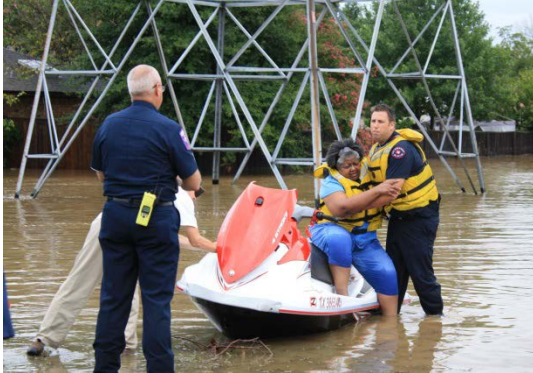
Figure 1 A Swift Water Rescue from a flooded neighborhood on September 8, 2010.

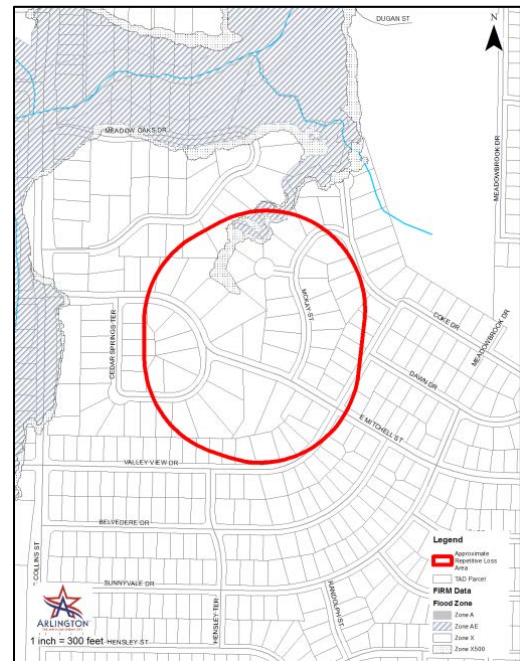
Flooding is related to adjacent earthen channel. This property is not within a Special Flood Hazard Area, but the channel conveys flow to an existing Zone A tributary to Johnson Creek that is located approximately 150 feet north of the property line. The City's drainage concern database has three reports dating back to 1995. In 1996, City forces widened the existing channel. In 2001, the homeowner reported flooding again. The May/June 2015 rain events flooded the home again. This property has been included in a FEMA Flood Hazard Mitigation Grant (HMGP) for buyout.

As of November 30, 2015, there is one repetitive loss property in this area that has made 2 claims for since 1977. The claims occurred in 1979 and 1981.

Potential Mitigation Approaches

If the HMGP grant is approved, this property will either be purchased with the FEMA grant funding later in 2016. If the grant is not received, then City funds will likely be used to purchase the property at a later date.
